# **Reliability of CGA/LGA/HDI Package Board/Assembly (Final Report)**

Reza Ghaffarian, Ph.D.  
Jet Propulsion Laboratory  
Pasadena, California

JPL Publication 14-14 9/14

NASA Electronic Parts and Packaging (NEPP) Program  
Office of Safety and Mission Assurance

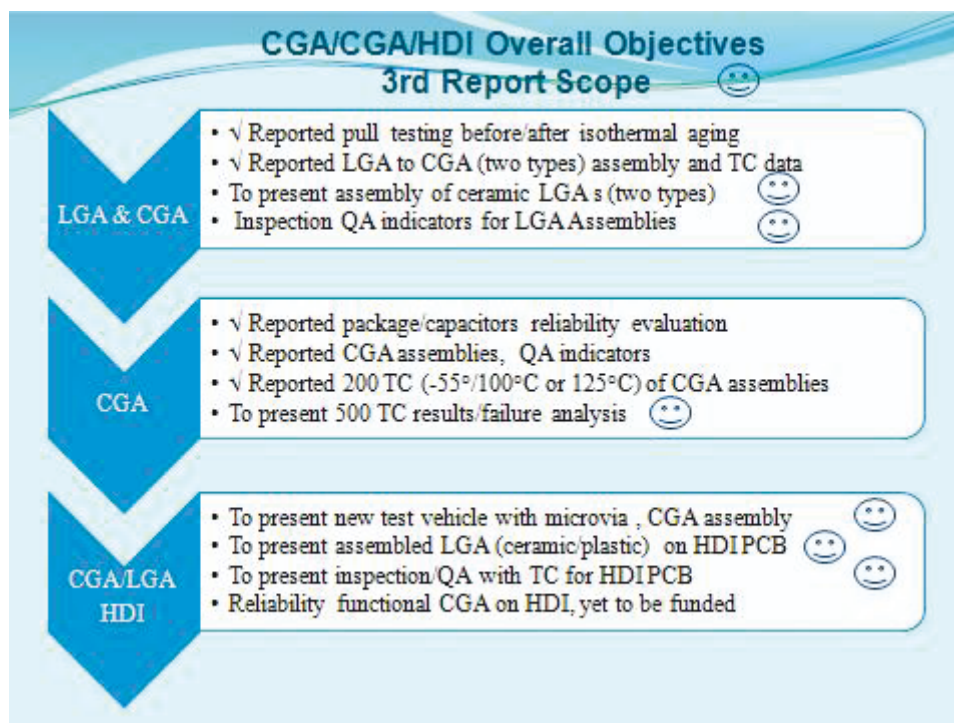
**Figure 1-1.** Test matrix for CGA/CCGA/HDI package/board/assembly program with identification of the key areas of investigation and those presented in this report (smiley face).

Figure 1-1 summarizes the overall objectives and approaches of the reliability evaluation of ceramic column grid array/land grid array/high density interconnect (CGA/LGA/HDI) of package, board, and assembly. Those marked in Figure 1-1 with smiley faces are recent data and are covered in this report. This report presents only a brief reference to the topics that were reported in the previous publications on this subject [1, 2]. Reliability of functional CGAs on HDI is considered to be the ultimate challenge that is yet to be evaluated. Thus far, all key manufacturing and reliability evaluations are established through using daisy-chain packages for assemblies since functional packages not only are costly, but also they are not designed for solder-joint failure analysis. The overall goal of this task is to develop qualification guidelines for advanced high input/output (I/O) CGA and LGA assembled onto both conventional and HDI printed circuit/wiring boards (PCB/PWB). This report presents thermal cycling test data for up to 500 thermal cycles for CGA assemblies with emphasis on understanding the key factors affecting failures and mechanisms. Then, it presents lessons learned on assembly of LGAs, both plastic and ceramic, onto conventional and HDI PCBs.

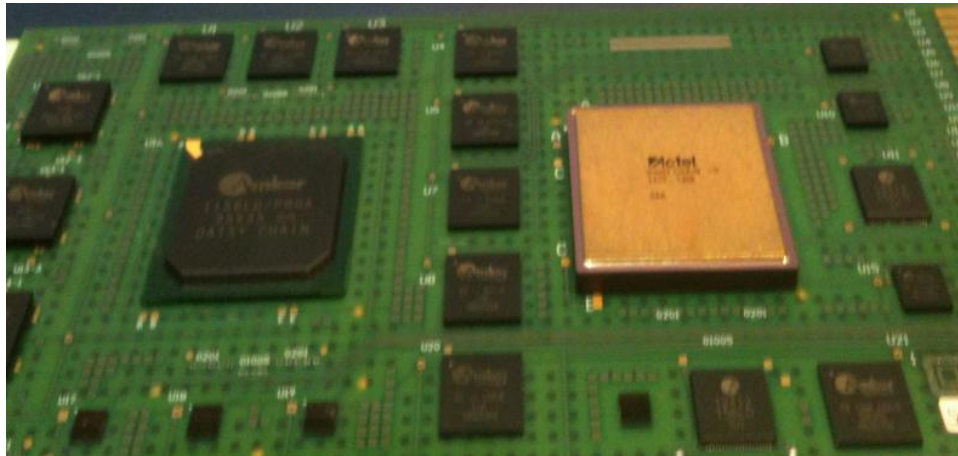
**Figure 1-2.** New test vehicle design (TV6) showing plastic (left, at the center) and ceramic (right, at the center) high I/Os (1156 and 1272) land grid arrays with a number of other fine pitch packages. The printed circuit board has a number of microvia daisy chains (HDI).

Additionally, a new test vehicle (TV) was designed with HDI (microvia) daisy-chain patterns covering two high I/O LGA packages as well as a variety of fine pitch advanced electronics packages (see Figure 1-2). The high I/O LGAs were a ceramic LGA with 1272 land pads and a plastic LGA with 1156 land pads. LGA packages were assembled onto a PCB in order to understand generic process, workmanship, and reliability issues associated with both ceramic and plastic LGA assembly. This approach is of interest because of a much wider implementation of restriction of hazardous substances (ROHS)—LGA is ROHS compliant. It is also interesting to note that recently a major CGA package supplier announced that it will provide packages only in LGA (CN) style even though the newer announcement may relieve this concern. During LGA assembly process development, we encountered numerous challenges, mostly for the high I/O ceramic LGA package assembly onto PCBs.

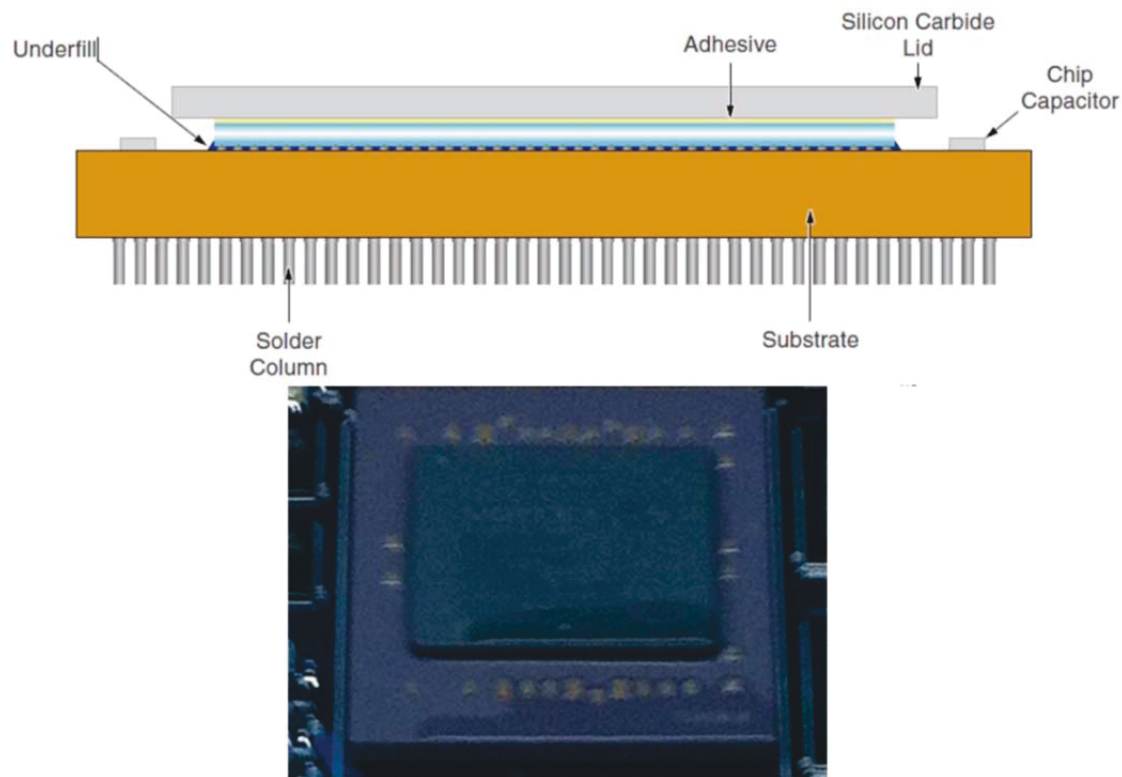
**Figure 2-1.** Construction of CGA 1752 I/O package (top) and photo of package showing the exposed chip capacitors.

substrate, and these capacitors are exposed. Figure 2-1 shows a generic construction of this package provided by the manufacturer along with a photo of the package from the top. Inspection of the chip capacitor solder joints for a package received for initial evaluation revealed a number of solder joints that would be unacceptable if NASA workmanship standards were considered as a baseline. For this reason, the solder joints of these chip capacitors were further characterized after an individual package was subjected to a limited number of thermal shock cycles. The results of inspection, environmental evaluation, and optical and SEM evaluation of cross-sectioned base metal electrode (BME) capacitors are discussed in the previous reports [1-2]. However, this report presents the recent BME dye-and-pry failure analysis results for a thermally cycled CGA assembly.

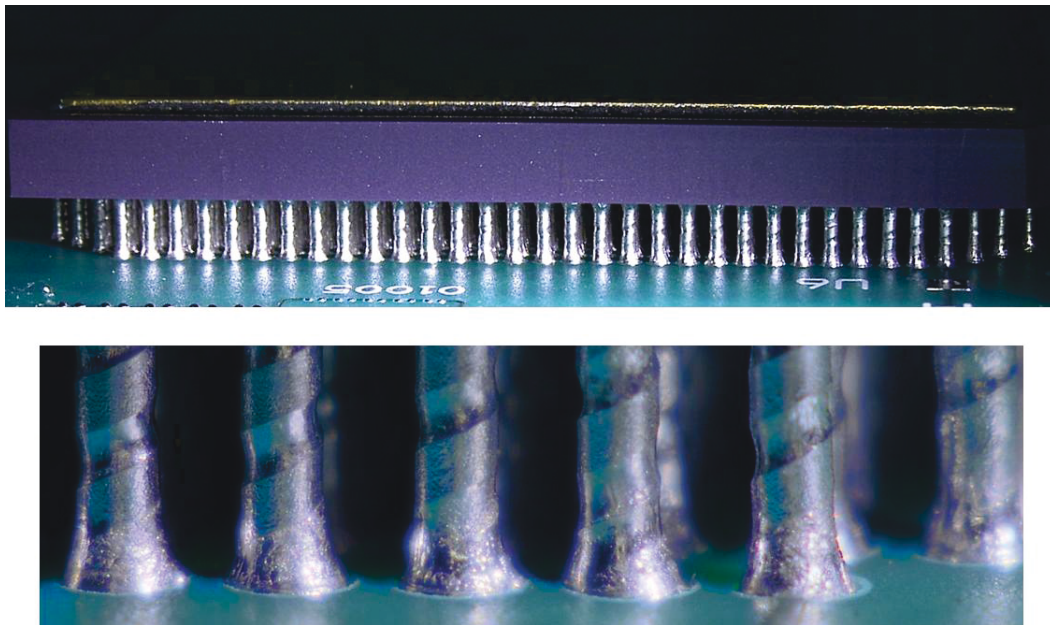
**Figure 2-2.** Representative photomicrographs of solder joint quality after 100 thermal cycles ( $-55^{\circ}/100^{\circ}\text{C}$ ) for CGA1272.

Damage progress with thermal cycling was established using an optical microscope. Figures 2-2 and 2-3 present representative photomicrographs at 100 and 500 thermal cycles ( $-55^{\circ}$  to  $100^{\circ}\text{C}$ ) for CGA 1272 I/Os showing solder joint condition and damage progression. Damage noticeable from these photomicrographs can be categorized as follows:

- CGA1272 with copper-spiral column showed good solder joint uniformity and wetting, and concave solder surrounding columns (360-degree solder coverage). A minimum of solder damage was detected due to 100 thermal cycles, and the damage became more pronounced at 500 cycles; solder/columns showing signs of graininess representing tin-lead solder grain growth due to exposure at  $100^{\circ}\text{C}$  during thermal cycling. Column rotational distortions were minimal, except for graininess and shedding fine particulate of solder exposed between the copper wrap at 500 thermal cycles. In addition, there were minimal apparent column shifts due to shear-induced deformation resulting from the CGA/PCB coefficient of thermal expansion (CTE) during thermal cycling.

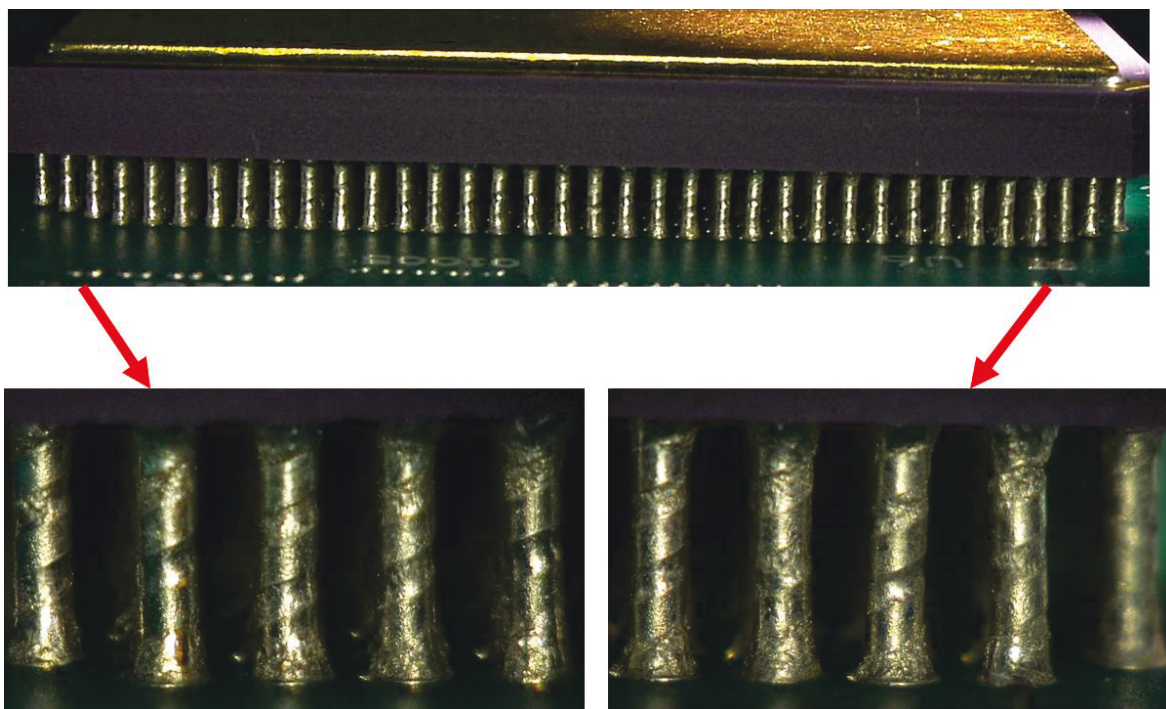
**Figure 2-3.** Representative photomicrographs of solder joint quality after 500 thermal cycles ( $-55^{\circ}/100^{\circ}\text{C}$ ) for CGA1272.

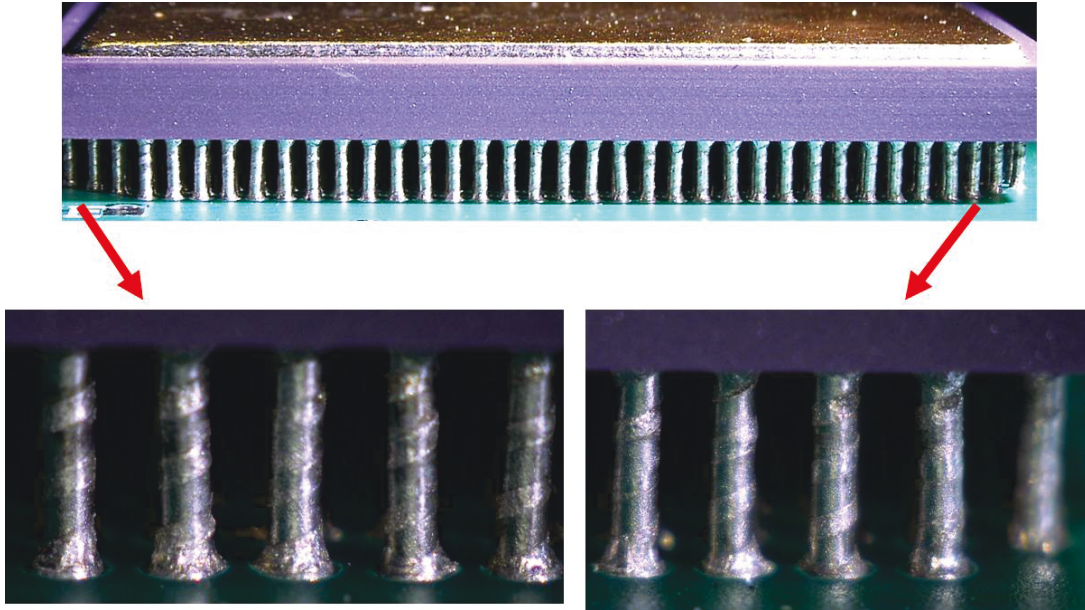
**Figure 2-4.** Representative photomicrographs of solder joint quality after 500 thermal cycles (-55°/125°C) for CGA1272.

Visual inspection was performed to establish damage progression of the outer columns of CGAs at thermal cycling intervals by optical microscopy. Figure 2-4 presents representative photomicrographs at 500 thermal cycles ( $-55^{\circ}$  to  $125^{\circ}\text{C}$ ) for CGA 1272 I/Os showing solder joint condition and damage progression. Damage due to thermal cycling, noticeable from these photomicrographs, can be summarized as follows:

- CGA1272 with copper spiral columns showed good solder joint uniformity and wetting after assembly.
- However, some solder damage is apparent at 500 cycles; they show noticeable signs of graininess and particulate shedding of solder within copper wrap, which is representative of tin-lead solder grain growth due to long exposure at  $125^{\circ}\text{C}$  during thermal cycling and local CTE mismatches.
- Column rotational distortion is low, even with such high signs of graininess.
- There are no apparent column shifts due to thermal cycling.

So, similarly to thermal cycle condition A ( $-55^{\circ}$  to  $100^{\circ}\text{C}$ ), less deformation occurred for CGA1272 with lower package dimension and higher rigidity of columns than those of CGA1752 —both factors induce lower thermal stress on solder joint attachment.

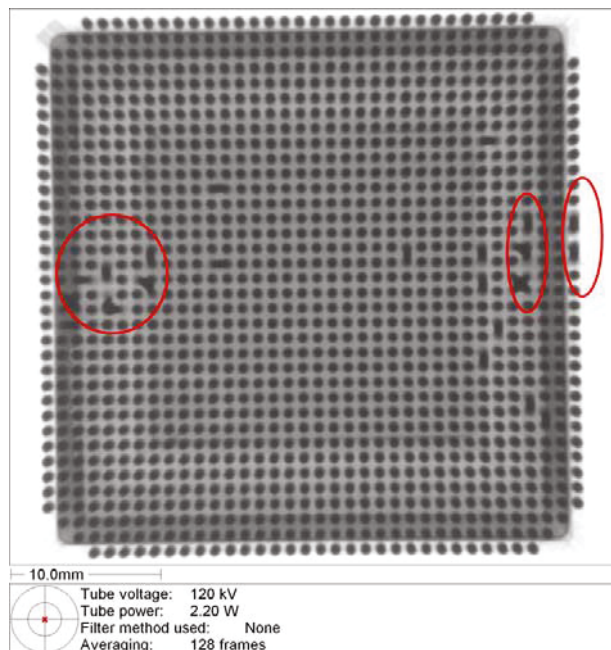
**Figure 2-5.** Representative 2D real time X-ray image of TV-032 assembled with rework station that showed a number of instances of solder column bridging.

The first use of the rework station for assembly of CGA1272 resulted in solder bridges (see Tv5-032). Daisy-chain resistance values were inconsistent including one pattern that showed opens. Visual inspection by optical microscopy revealed solder column bridges at the package periphery. A real-time 2D X-ray system was used to determine the extent of bridging for this assembly. Figure 2-5 shows X-ray photomicrographs of this CGA package revealing a number of other bridges under the package away from the package periphery.

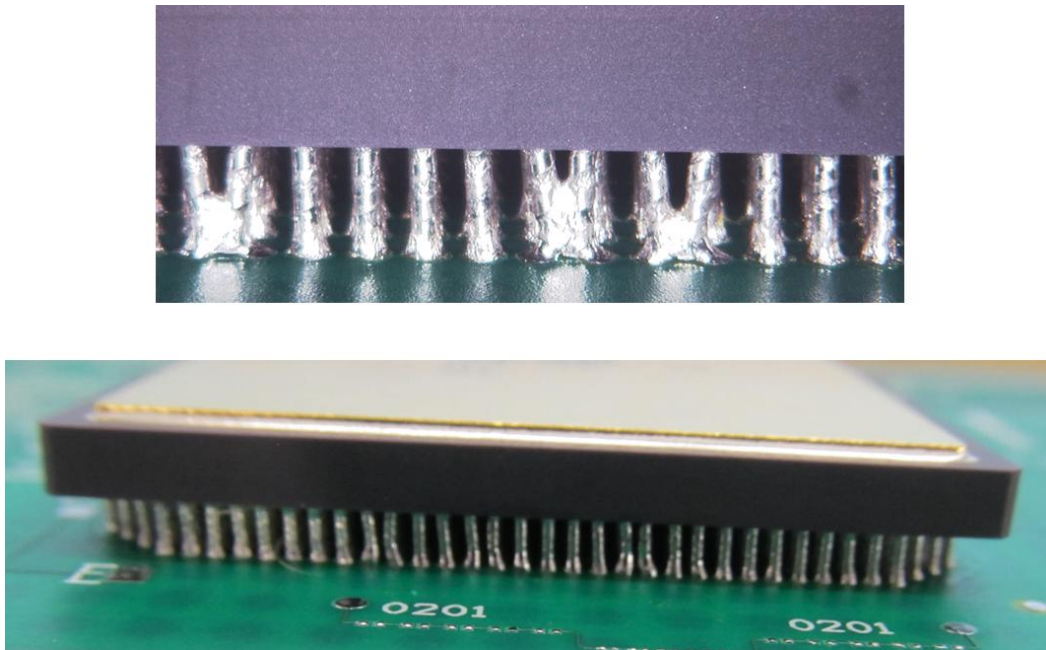
**Figure 2-6.** Optical photomicrographs of CGA1272 assembled with the rework station after assembly and after removal of peripheral solder column bridges.

One reason for column bridging is thought to be the size of nozzle employed being the same as the package; this did not allow an effective flow of hot air during the reflow process. For a subsequent reflow, a new nozzle was designed that was slightly larger than the package size. Also, the reflow process was modified by increasing maximum temperature and dwell time. The new process parameters were implemented for assembly of another CGA1272 on the PCB using a previously designed mini stencil for solder paste printing. Use of the new process and the rework station again resulted in a solder column bridge even though we were successful in removing the peripheral solder bridges (see Figure 2-6).

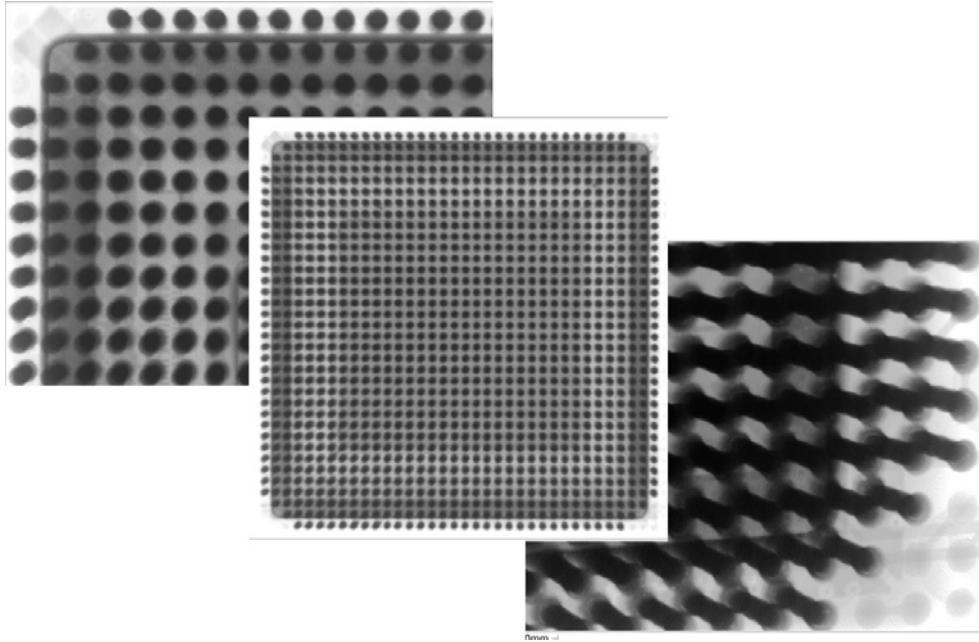
**Figure 2-7.** Representative of 2D real time X-ray of a CGA 1272 I/O assembled with rework station that showed no solder column bridging.

The above process was repeated using a new CGA1272 package; however, this time the solder paste behavior during reflow was monitored visually. The rework process had to be aborted two times just before solder reflow because of solder paste spreading during the initial heating process. After careful review of the process steps, the cause of solder paste spreading was identified. This enabled us to achieve an acceptable assembly process for CGA1272 assembly using the rework station. As apparent from Figure 2-7, a real time 2D X-ray revealed no solder column bridging. Even though the effect of such a process on behavior under thermal cycling is yet to be characterized as, “assembled,” test vehicles are considered to be acceptable. Further verification is required regarding the repeatability of this process.

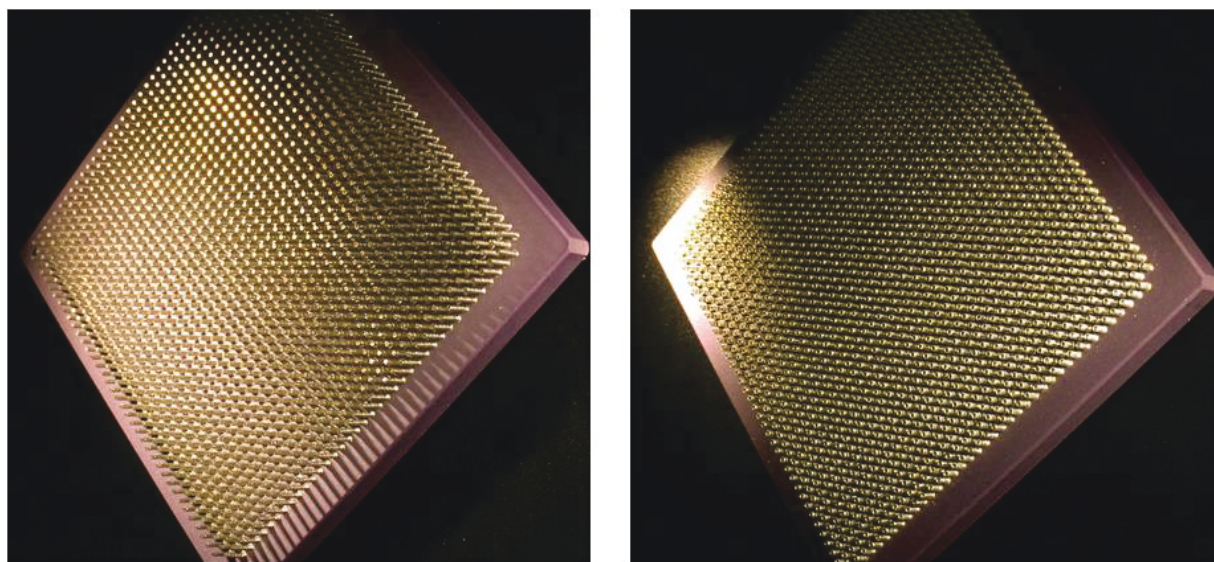
**Figure 3-1.** Representative photomicrographs of an LGA package after copper column (left) and micro-spring coil column (right) attachment.

The purpose of the following aspect of the investigation was to characterize the reliability of the CGA version of post column attachment of LGA1517 packages with 1-mm pitch. LGAs were first subjected to either copper-wrapped column or microspring coil attachment prior to evaluation. Column attachment integrity was evaluated by subjecting a CGA version to isothermal aging and pull testing before and at intervals during environmental aging [1,2]. Figure 3-1 shows photomicrographs of the LGA package after its conversion to CGA.

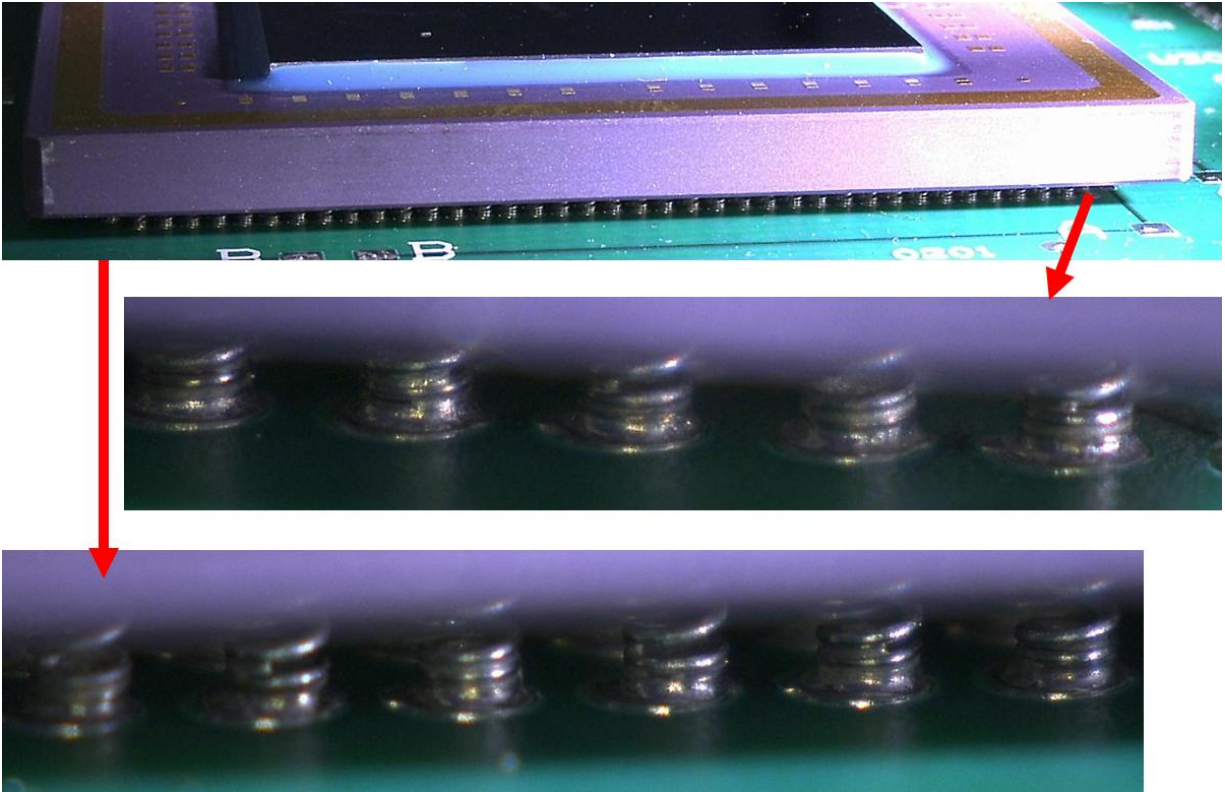
**Figure 3.2.** Representative photomicrographs of solder joint quality of microspring column attachment after 500 thermal cycles ( $-55^{\circ}/100^{\circ}\text{C}$ ) for CGA1517.

Figures 3-2 and 3-3 present representative photomicrographs of solder joint condition of two CGA 1517 I/Os, one with microspring and the other with copper-wrapped columns, respectively. Damage appears to be minor for both cases due to 500 thermal cycles (–55°C to 100°C). Only slight dullness indicates some damage due to cycling, and there are no signs of microcracks.

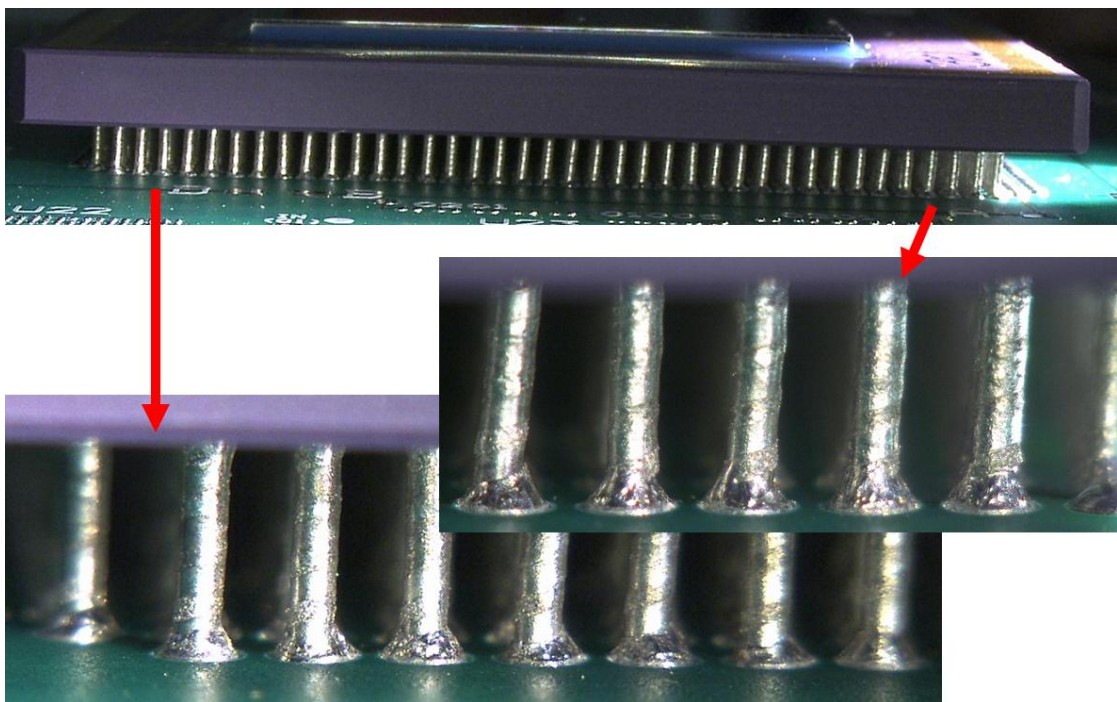
**Figure 3.3.** Representative photomicrographs of solder joint quality of copper-spiral column attachment after 500 thermal cycles ( $-55^{\circ}/100^{\circ}\text{C}$ ) for CGA1517.

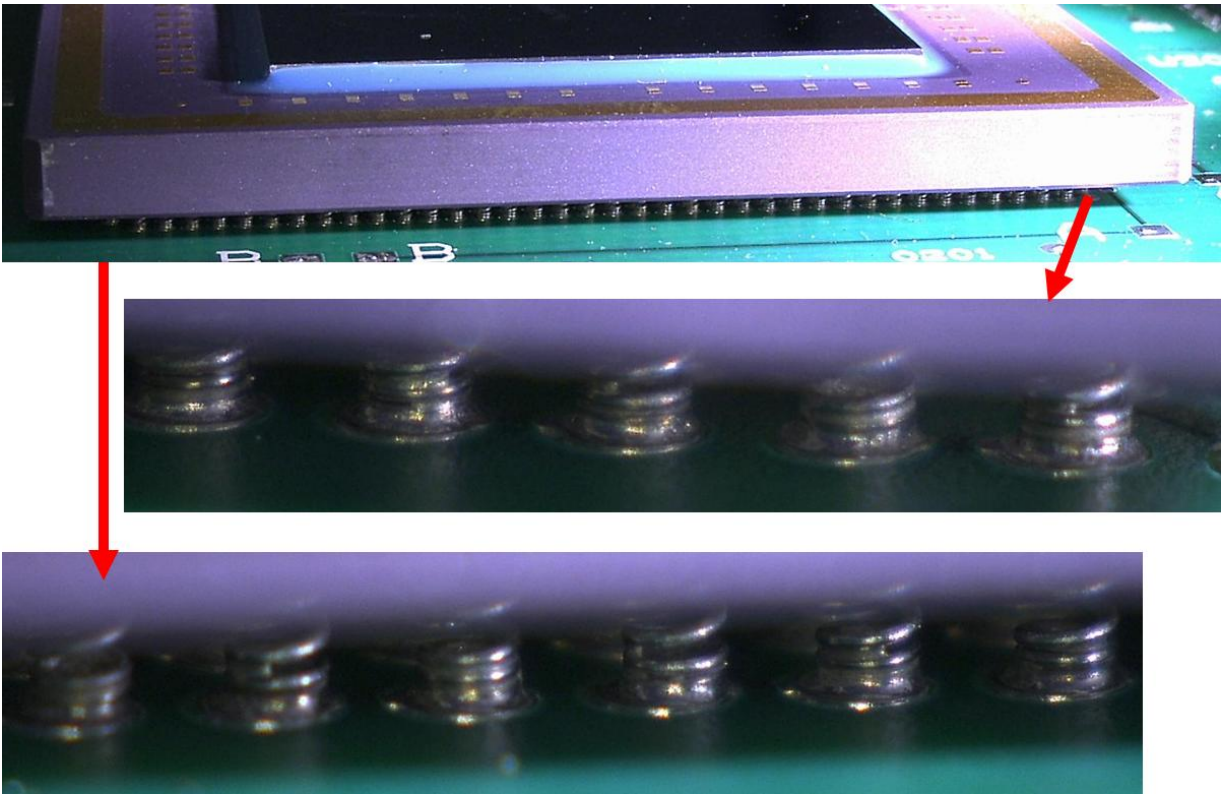
**Figure 3-4.** Representative photomicrographs of solder joint quality of microspring column attachment after 500 thermal cycles ( $-55^{\circ}/125^{\circ}\text{C}$ ) for CGA1517.

In addition to daisy-chain monitoring for CGA1272, visual inspection by optical microscopy was also performed for all CGAs to establish damage progression of the outer columns. Figures 3-4 and 3-5 present representative photomicrographs of solder joint condition for CGA 1517 with microspring and copper-wrapped columns after 500 thermal cycles ( $-55^{\circ}\text{C}$  to  $125^{\circ}\text{C}$ ). A slightly darker appearance of solder joints at the PCB side of the microspring column attachments indicates a slight sign of damage due to 500 thermal cycling.

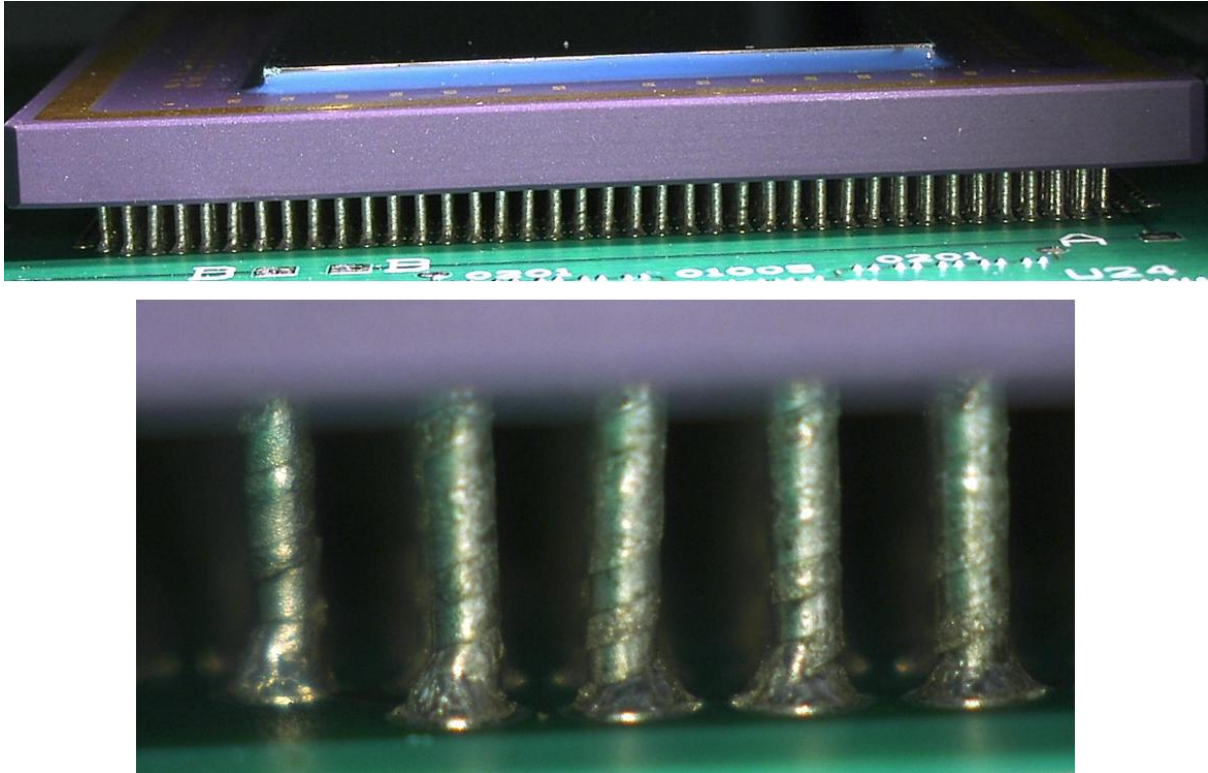
**Figure 3-5.** Representative photomicrographs of solder joint quality of copper-spiral column attachment after 500 thermal cycles ( $-55^{\circ}/125^{\circ}\text{C}$ ) for CGA1517.

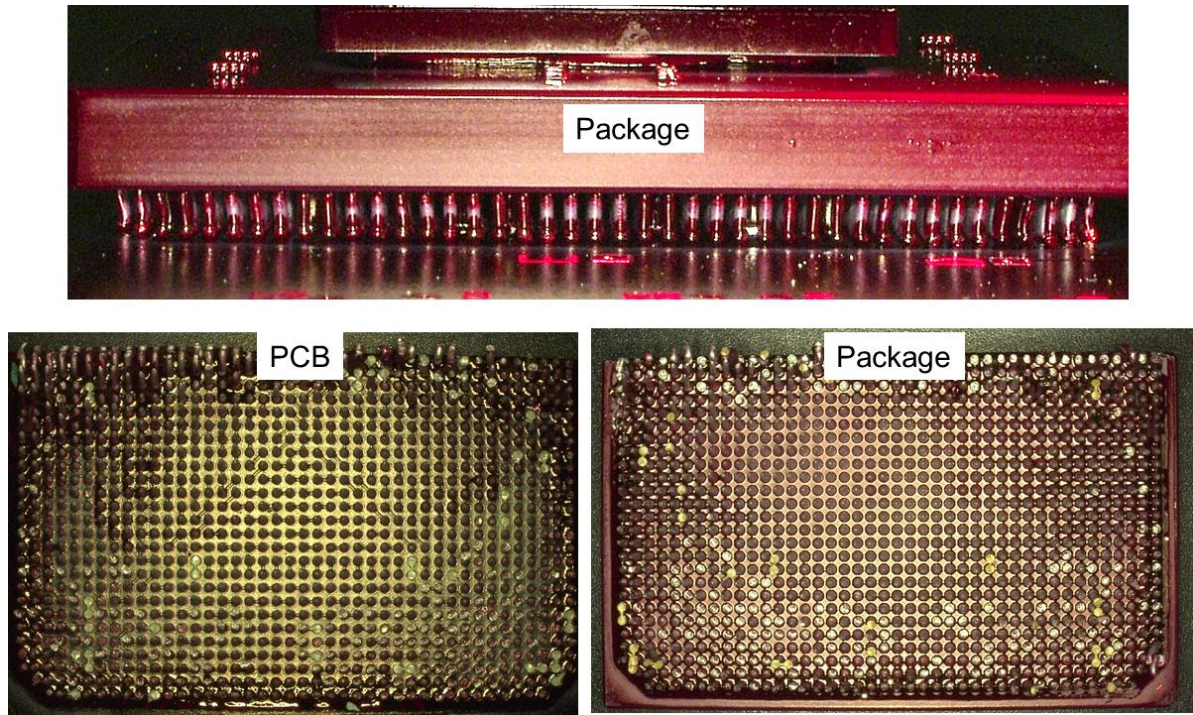
**Figure 4-1.** Representative dye-and-pry photomicrographs of failures at assembly before pry (top), at PCB (bottom-left), and at package (bottom-right) sites after pry for CGA1752 after cycling ( $-55^{\circ}/125^{\circ}\text{C}$ ).

CGA1752 with BME capacitors on the ceramic substrates after thermal cycling ( $-55^{\circ}$  to  $125^{\circ}\text{C}$ ) and vibration-to-failure were subjected to failure analyses. The assembly was cut in half; one-half for dye-and-pry and the other half for cross-sectioning evaluation. Figure 4-1 shows photomicrographs of red-dyed assembly before and after prying; it shows complete separation of the assembly into halves—package and PCB and failure mechanisms. The total number of columns in the section was 1034 sites, in which 38 pulled through the PCB pad lifting (cratering), about 3.7%. Since there was no stain on the lifted pad, the pad lifts were considered to be due to prying, not cratering due to thermal cycling or vibration. The other noticeable failure mechanism was a half-cone solder cavity on the PCB pads. The cavity represents the condition of solder fillet after reflow, with only partial solder fillet formation on the PCB pads. Asymmetrical solder fillet with a slight degree of tilt is the norm for the pure solder column and is acceptable for yield and reliability. It is postulated that during prying, columns were first pulled apart from the no-fillet section, and then solder was deformed during the last stage of separation and stretched to form a half-cup solder left on the PCB pads. The majority of the separated sites from the PCB pads, only 113 sites (11.3%), were from the package pads.

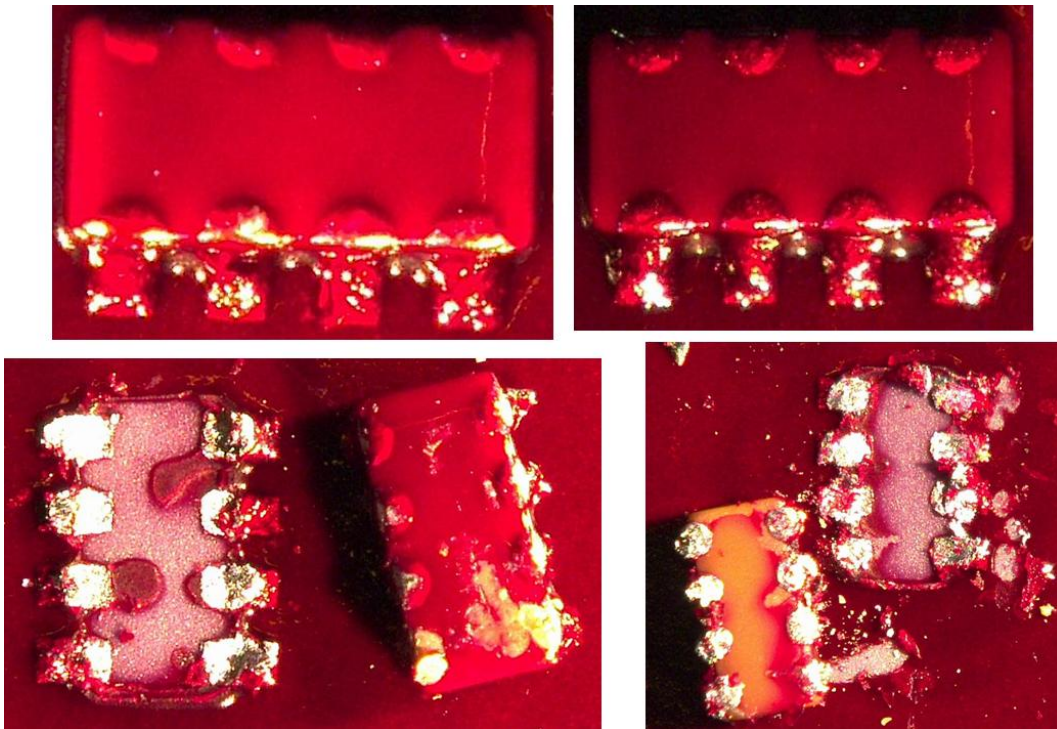
**Figure 4-2.** Representative dye-and-pry photomicrographs of failures BME capacitors on CGA1752 substrate before pry at assembly (top) and after pry (bottom) after cycling ( $-55^{\circ}/125^{\circ}\text{C}$ ).

Figure 4-2 shows the BME capacitors before and after dye-and-pry showing stained red substrate and the package pads. Areas of red dye are apparent on all pads; however, no full red coverage of the pads was observed. Lack of full red stain indicates that there was no solder joint full failure of the BMEs despite the number of thermal cycles. Partial failures are apparent.

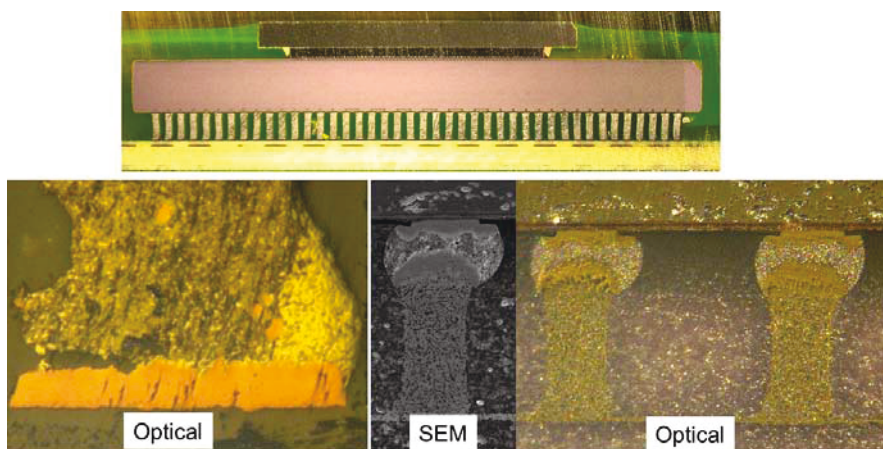
**Figure 4-3.** Representative optical and SEM cross-sectional photomicrographs of CGA1752 showing damage of solder joint on PCB and integrity of the flip-chip die within package after cycling ( $-55^{\circ}/125^{\circ}\text{C}$ ).

Figure 4-3 shows optical photomicrographs taken at a lower magnification in order to reveal the location of polishing (near the center of the package) and the overall package configuration. It includes the optical photomicrographs of the flip-chip die and column solder joints at a higher magnification. For reference, a scanning electron microscopy (SEM) image of the corner flip-chip bump is also included in the figure. There was no evidence of cracking of solder bumps in those scanned optically and by SEM. However, partial cracking of the corner columns are apparent from the magnified image. Note that the edge columns at the center section of a package assembly generally were exposed to lower stresses due to the CTE mismatches compared to the corner columns of CGA package with the largest distance to neutral point (DNP). Hence, the corner columns were exposed higher stresses and developed more severe cracks.

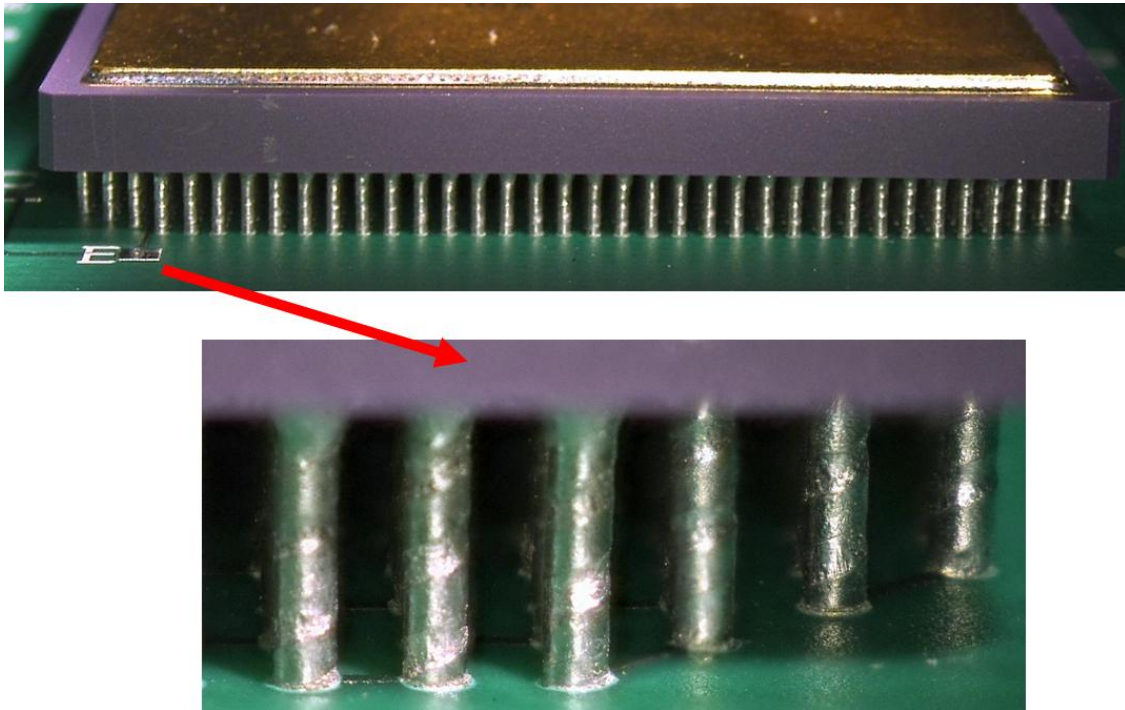
**Figure 4-4.** Representative photomicrographs of solder joint quality of copper-spiral column attachment after 300 thermal cycles ( $-55^{\circ}/125^{\circ}\text{C}$ ) for TV4-CGA1272 with pad the same size as solder column diameter.

lack of solder joint fillets, the solder joints showed signs of microcracks and failed much earlier than the test vehicle built under a standard condition (TV5).

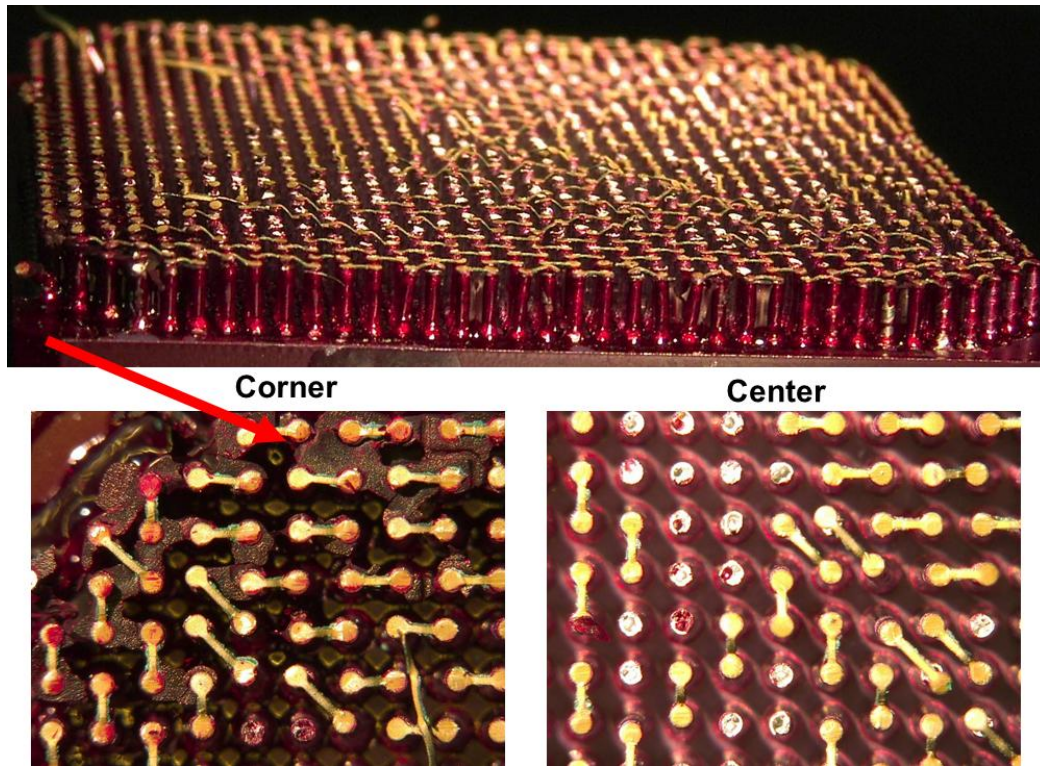
**Figure 4-5.** Representative dye-and-pry photomicrographs of failures at package site for CGA1272 after cycling ( $-55^{\circ}/125^{\circ}\text{C}$ ).

After early failure detection by daisy chain, the assembly was subjected to red dye first and then was pried for failure location detection. Figures 4-5 and 4-6 compare the failure mechanisms at the package and at the PCB sites. More than 96% of failures were due to pad cratering and lift. It appears that integrity of pad adhesion might have been compromised with such a pad configuration. Full red stains on the pad lift in the corner pads confirm early failure occurrence due to the lack of solder fillet.

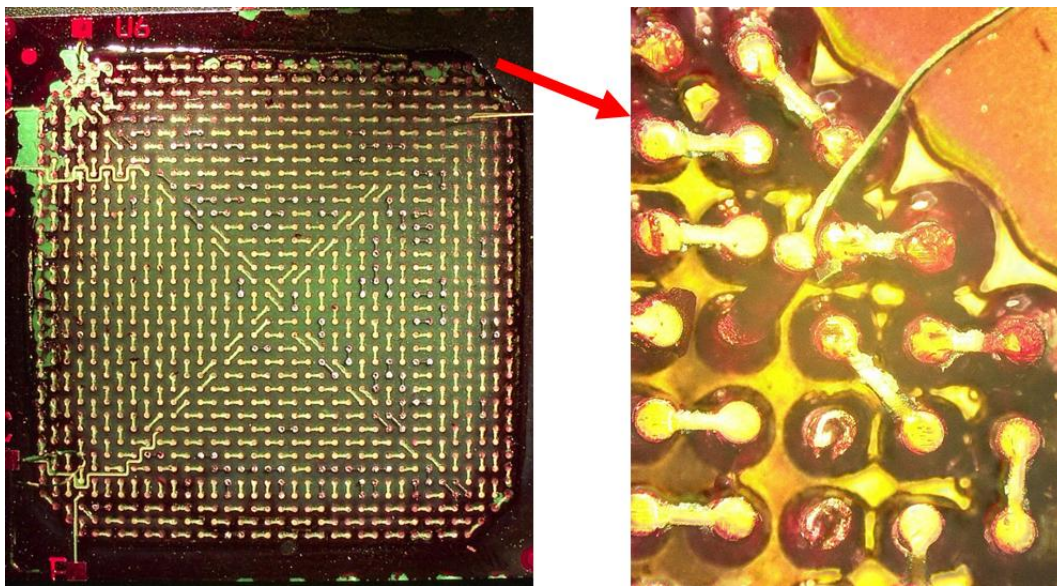
**Figure 4-6.** Representative dye-and-pry photomicrographs of failures at PCB site for CGA1272 after cycling ( $-55^{\circ}/125^{\circ}\text{C}$ ).

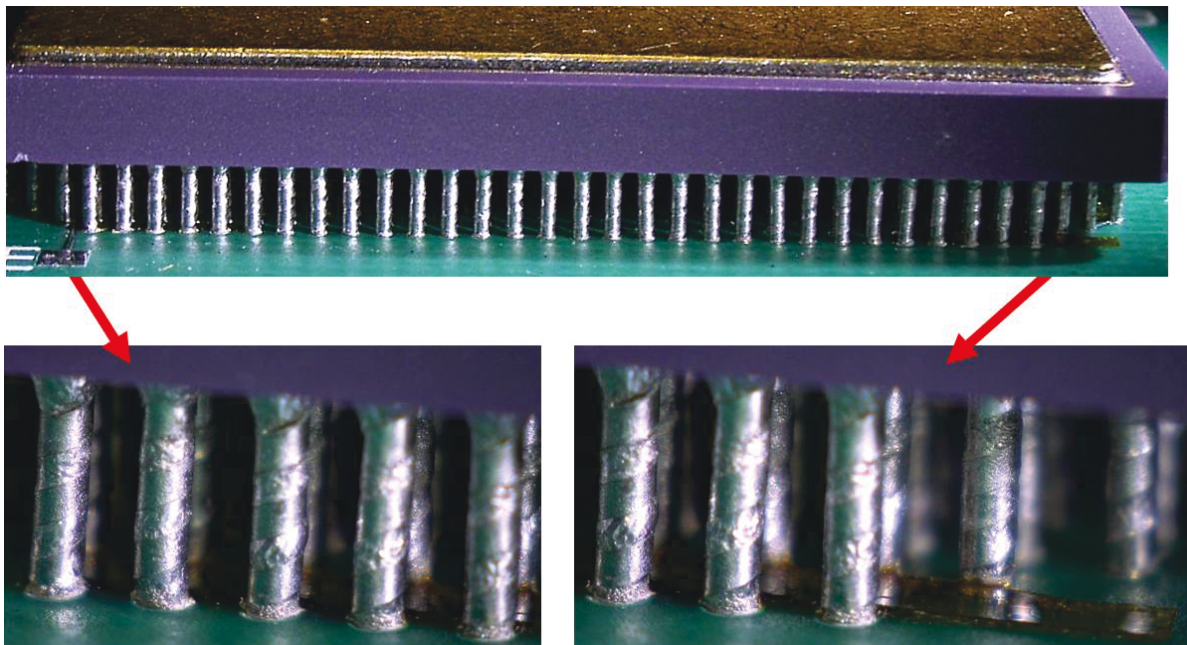
**Figure 4-7.** Representative photomicrographs of solder joint quality of copper-spiral column attachment after 500 thermal cycles ( $-55^{\circ}/125^{\circ}\text{C}$ ) for CGA1272. Kapton defect at the corners was introduced before assembly.

The second defect was introduced by adding foreign materials on selected pads in an attempt to generate a defect with a known crack size. Two approaches were considered for this purpose: (1) using Kapton tape, and (2) using marking in on the corner pads. It covered the four pads of each corner with 50% defect materials. The CGA1272 pad pattern was used for this purpose. Before paste printing, it was visually verified that subsequent paste prints did not fully cover these pads. Unfortunately, the use of Kapton tape was not successful. The Kapton tape moved during reflow and detached subsequently. The Kapton separation generated a solder joint open detected by the open loop. Figure 4-7 shows TV4-023 with Kapton floating near the corner of the CGA1272 assembly. Lack of good solder fillet due to smaller pad size also is apparent.

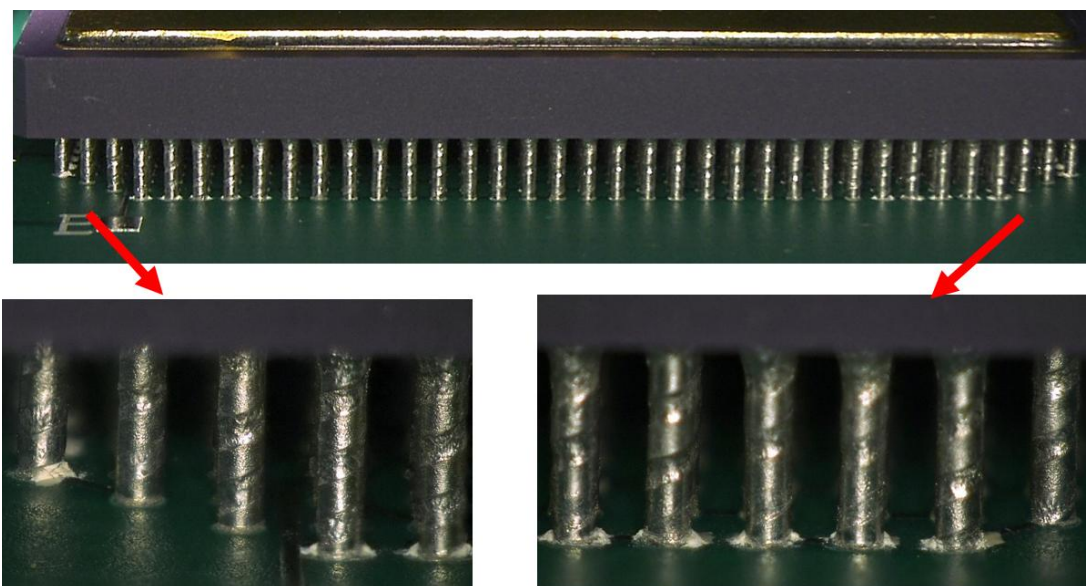
**Figure 4-8.** Representative photomicrographs of solder joint quality of copper-spiral column attachment after 300 thermal cycles ( $-55^{\circ}/125^{\circ}\text{C}$ ) for CGA1272. The ink defect at the corners was introduced before assembly.

The use of ink on the pads appeared to be acceptable after assembly showing the daisy-chain loops with resistance values. However, it did show signs of significant damage and early failures. Figure 4-8 shows the damaged condition of the corner columns for this test vehicle after 300 thermal cycles ( $-55^{\circ}/125^{\circ}\text{C}$ ). No solder joint open yet was detectable by daisy-chain measurement at this number of cycles. At slightly higher cycles and contrary to other similar assemblies, but with a larger pad size and no defect, this assembly showed signs of daisy-chain opens representing solder joint failure, most probably due to the ink defect.

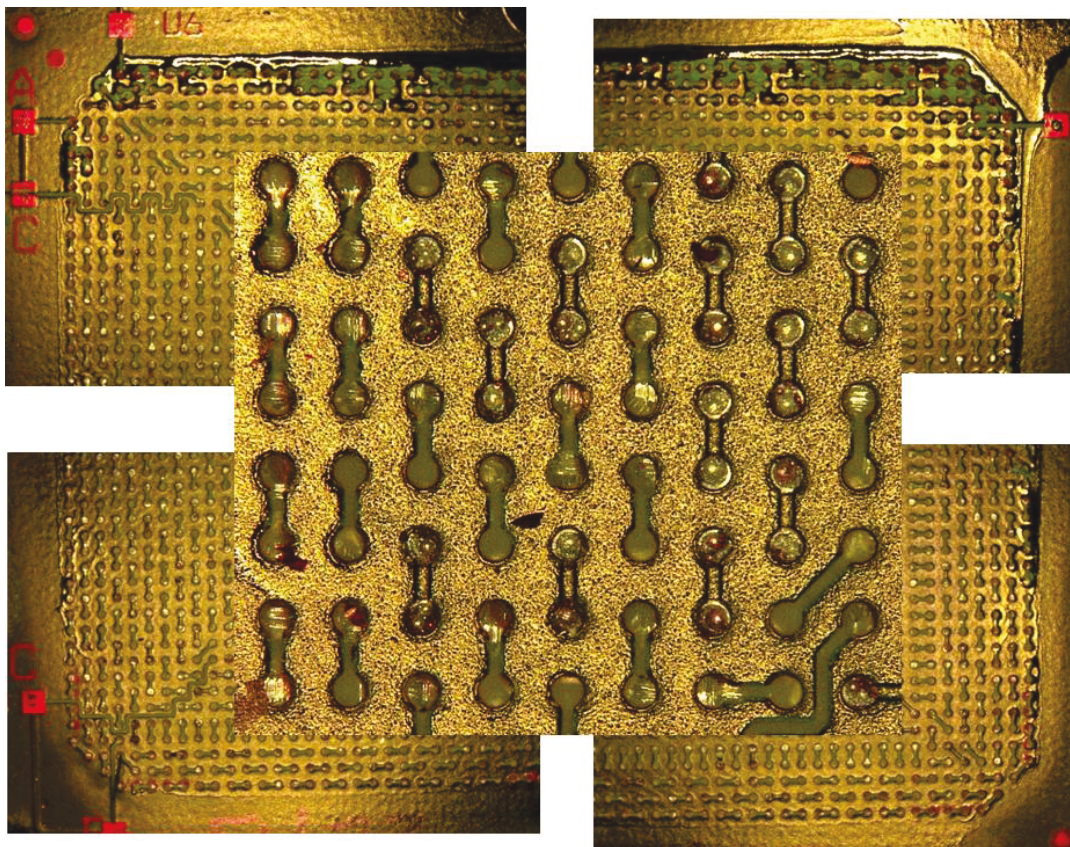
**Figure 4-9.** Representative dye-and-pry photomicrographs of failures at PCB site for CGA1272 with the ink defect and smaller PCB pad sizes after cycling ( $-55^{\circ}/125^{\circ}\text{C}$ ).

After failure of this assembly, the dye-and-pry technique was used to verify failure mechanism due to the ink defect and smaller pad size. Figure 4-9 shows photomicrographs of the PCB pad pattern after full separation due to prying. Photomicrographs of the four corners and an enlarged pattern pads are included in the photos. As expected, stain covered corner pads indicate a failure condition from the PCB pads. This however, was not the case for the most of the other pads, even though copper pad separation from the PCB was dominant. The package pad sites showed a lower number of separations (see Figure 4-10). The white reflections at the separated package represent pad separation during thermal cycling. The failures from either package or PCB sites clearly show competing failure mechanisms; in which for this case, failure becomes dominant at the PCB sites. The ink defect and smaller pad sizes favored failure at the PCB sites.
